# **Inspection Report**

Red Mountain Inspections LLC Chad M. Allen Alabama: HI-4007 504 Cattail Circle Gardendale, AL 35071 205-607-2082

123 Sample Street Birmingham AL 35216

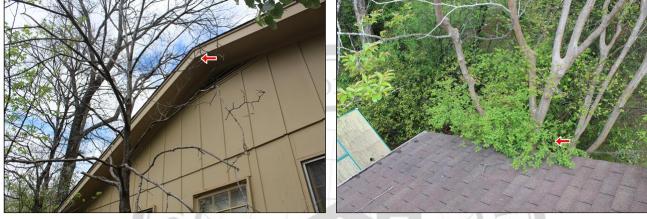
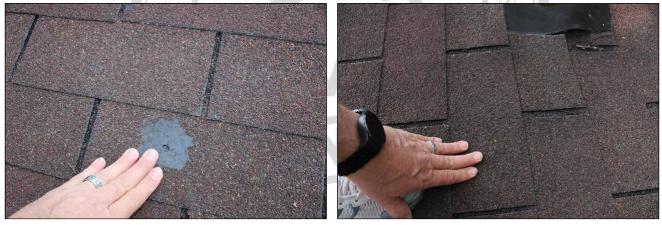
1.0 Item 1(Picture)

**1.0** Condition(s) observed with Roof Covering(s):

- The tree limbs that are in contact with the roof should be trimmed to prevent damage of the roofing material where limbs are in contact.
- Several nails have backed out through the roof shingles. Repairs are needed to prevent further damage to the shingle(s) or moisture from entering the home where nails have backed out.
- Observed at least one damaged shingle. Repairs are needed to prevent moisture from entering the home where shingles are damaged.
- Observed deteriorated decking due to water entry at the service mast at rear of home, corrections are needed to prevent continued water entry / deterioration.

**Recommendation:** A qualified roofing contractor should inspect further and make corrections to item(s) as well as any other related condition discovered while performing repairs.

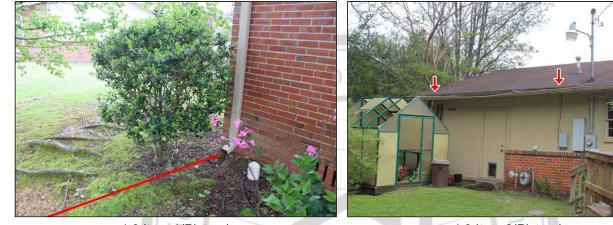
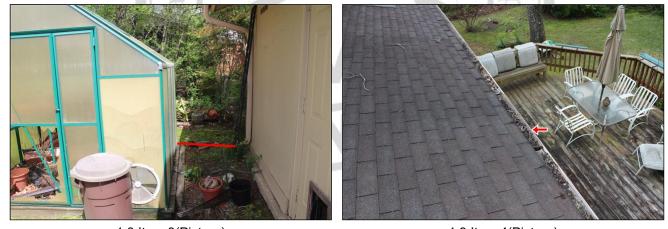
1.3 Item 1(Picture)

**1.3** Condition(s) observed with the Roof Drainage Systems:

- Loose roof drainage systems will need securing where loose.
- Downspout extenders should be installed as to discharge water away from the foundation.

**Recommendation:** A qualified roofing contractor should inspect further and make corrections to item(s) as well as any other related condition discovered while performing repairs.

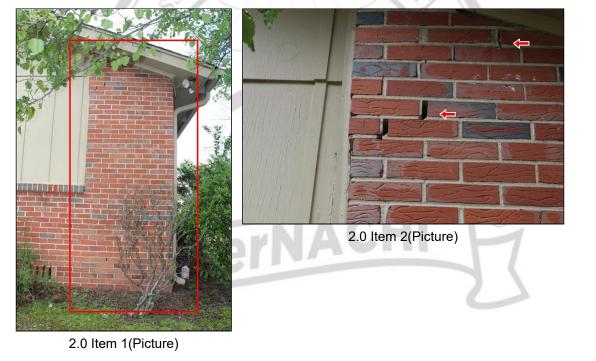
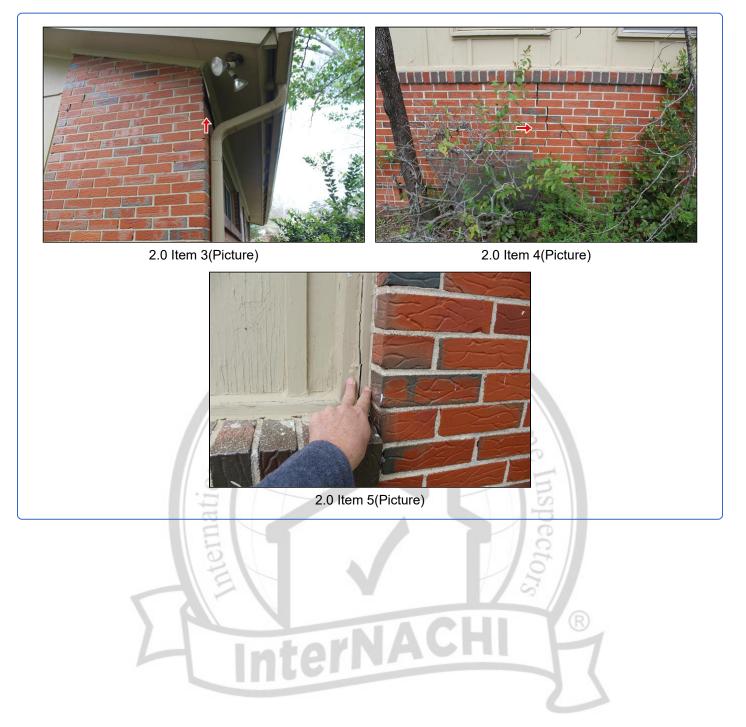
• Observed settlement and cracking in the mortar at the brick veneer at the left front corner of home. This does not appear to be a structural issue however it does appear that corrections are needed to prevent further movement / settlement of the brick veneer.

**Recommendation:** A qualified contractor should inspect further and make corrections to item(s) as well as any other related condition discovered while performing repairs.

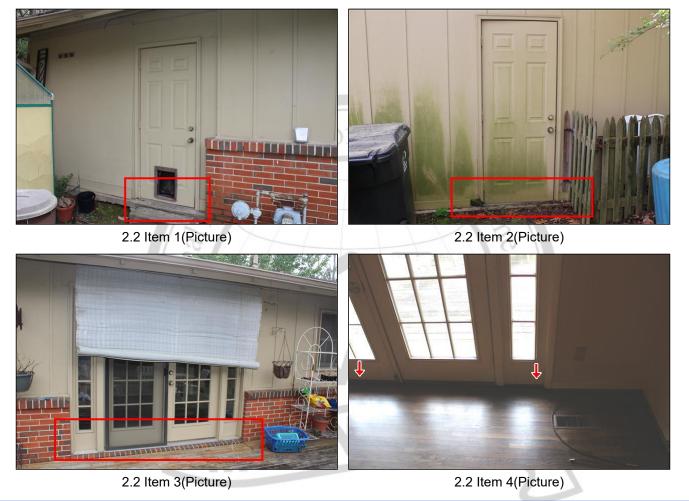
- **2.2** (1) Condition(s) observed with Doors (Exterior):
  - Areas of deterioration will need to be repaired, scrapped to remove loose paint, primed, caulked and painted at the exterior to prevent further deterioration.
  - Active water entry observed at the rear entry door where the interior flooring has deteriorated.
  - General maintenance of door caulking is needed at exterior side of door(s) where caulking has begun to fail/ missing.

**Recommendation:** A qualified contractor should inspect further and make corrections to item(s) as well as any other related condition discovered while performing repairs.

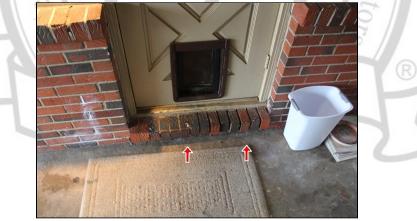
2.2 Item 7(Picture)

2.2 (3) Condition(s) observed with Doors (Exterior):

• Loose brick at the threshold will need to be re-secured.

**Recommendation:** A qualified contractor should inspect further and make corrections to item(s) as well as any other related condition discovered while performing repairs.

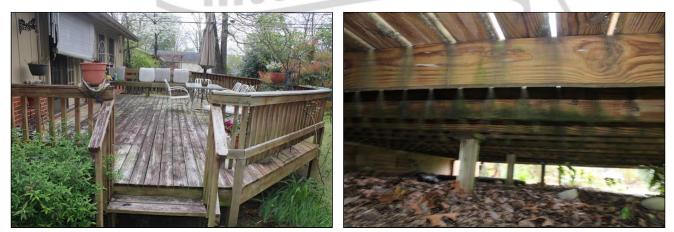
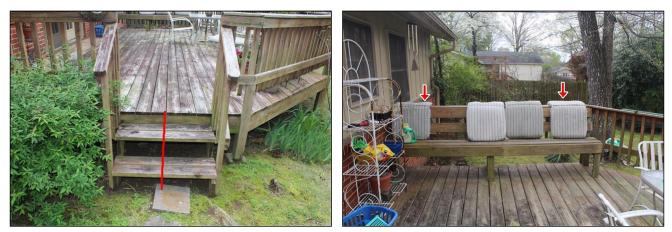
2.4 Item 2(Picture)

**2.4** (2) Condition(s) observed with Decks, Balconies, Stoops, Steps, Porches, Patio/Cover & Applicable Railings:

- Floor Joists under the rear deck are over-spanned which needs correction based on 10 lb. Dead Load, 40 lb. Live Load Table
- Missing center stringer will need to be installed.
- Required guards at open-sided walking surfaces, including stairs, porches, balconies or landings, shall be not less than 36 inches high measured vertically above the adjacent walking surface, adjacent fixed seating or the line connecting the leading edges of the treads.

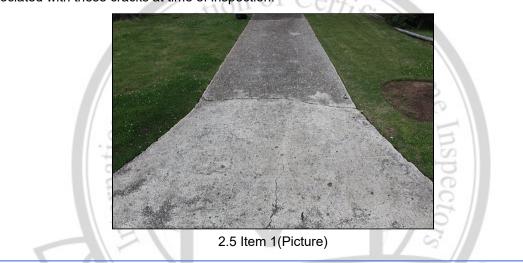
- 2.5 Condition(s) observed at Vegetation, Grading, Drainage, Driveways, Patio Floor, Walkways & Retaining Walls:
   Observed minor cracking in the driveway slab at the exterior, however we did not observe any concerns
  - associated with these cracks at time of inspection.

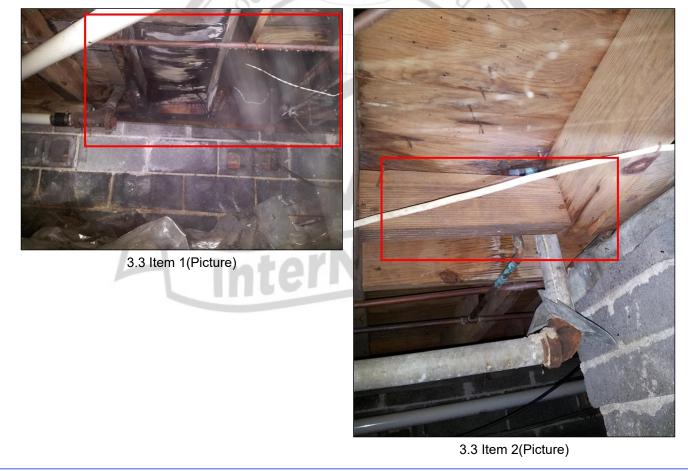
- The inspector observed deteriorated sub floor, floor joists, rim joist and sill plate beneath the kitchen sink due to an active plumbing leak at the supply line in this area. Further evaluation and corrections are needed to repair.
- Observed one floor joist beneath the master bath which has been improperly cut for plumbing lines. It appears that an additional support pier is needed to support the floor joist in this area.

**Recommendation:** A qualified contractor should inspect further and make corrections to item(s) as well as any other related condition discovered while performing repairs.

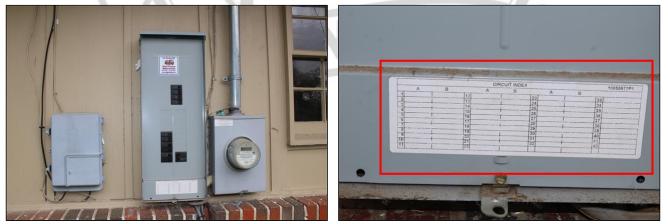
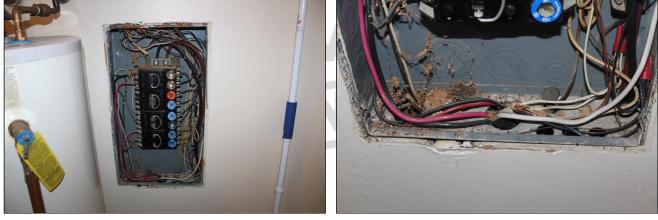
6.1 Item 2(Picture)

**6.1** (1) Condition(s) observed with the Meter Box, Main Disconnect, Service Grounding/Bonding, Main & Distribution Panel(s):

**6.1** (2) Condition(s) observed with the Meter Box, Main Disconnect, Service Grounding/Bonding, Main & Distribution Panel(s):

• All conduit and cables entering the equipment shall be fastened with approved connectors.

**Recommendation:** A qualified electrical contractor should inspect further and make corrections to item(s) as well as any other related condition discovered while performing repairs.

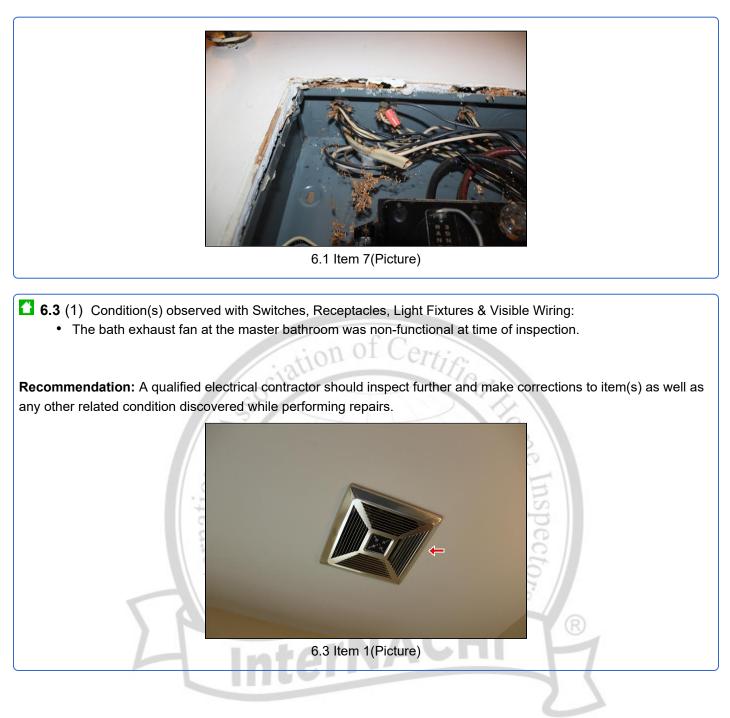
- Damaged or missing outlet / junction covers will need to be replaced.
  - Missing dimmer switch knob should be installed.

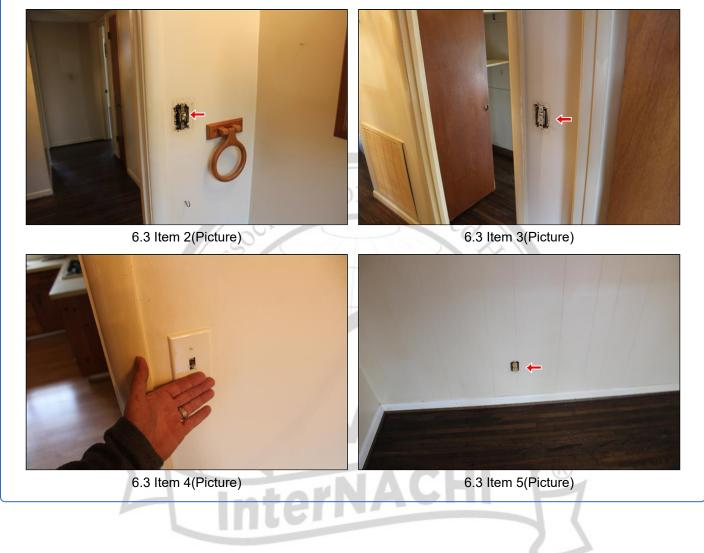
**6.3** (2) Condition(s) observed with Switches, Receptacles, Light Fixtures & Visible Wiring:

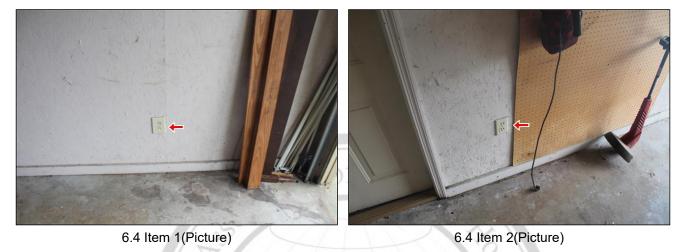
- 6.4 (1) Condition(s) observed with GFCI / AFCI Protection, Polarity & Grounding of Receptacles:
   One or more GFCI (Ground Fault Circuit Interrupter) receptacles did not trip/reset when tested (defective/ missing).
  - Garage

**Recommendation:** A qualified electrical contractor should inspect further and make corrections to item(s) as well as any other related condition discovered while performing repairs.

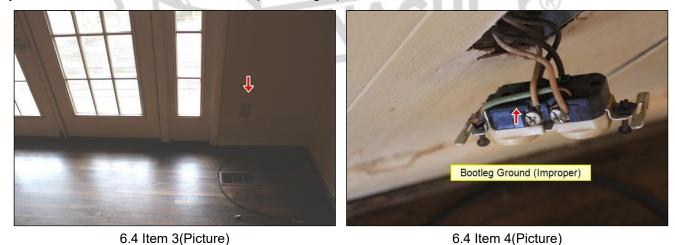
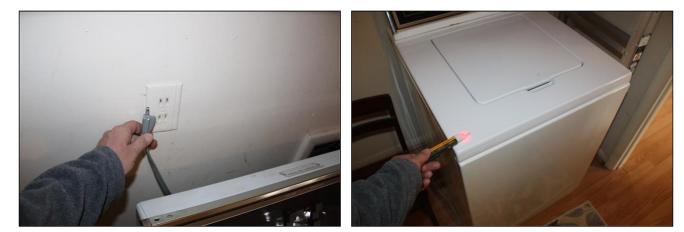
6.4 Item 5(Picture)

6.4 (2) Condition(s) observed with GFCI / AFCI Protection, Polarity & Grounding of Receptacles:

- "Three-Prong" outlets are not grounded, not labeled/not GFCI Protected. These outlets should be GFCI Protected with labeling stating "No Equipment Ground" or changed back to "Two-Prong" outlets.
- The laundry washing machine was observed to be energized at time of inspection. A 3 prong GFCI protected receptacle should be installed for this appliance.

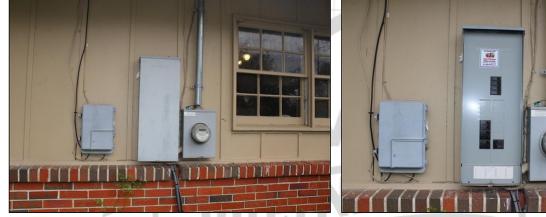
6.5 Item 1(Picture)

6.5 The main panel box is located at the exterior.

The sub panel box is located at the laundry room.

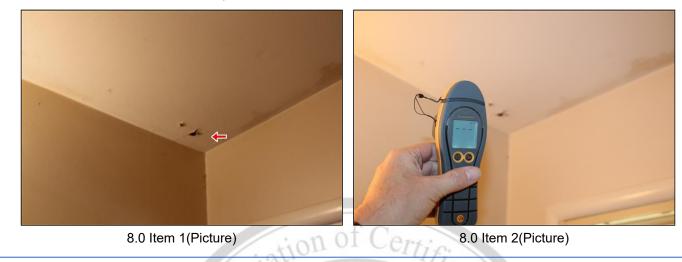
- **8.0** Condition(s) observed with Ceilings:
  - Observed previous water stains at the interior ceiling(s), however this area was confirmed dry using a moisture meter at time of inspection.

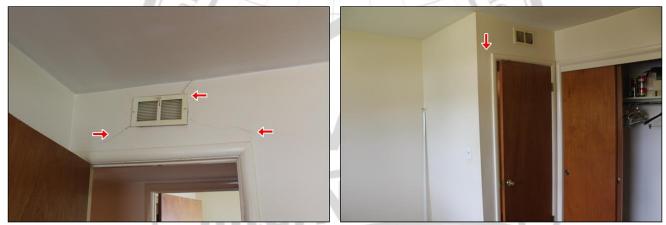
8.1 Item 1(Picture)

- 8.1 Condition(s) observed with Walls:
  - Observed hairline cracks at the interior sheetrock wall(s), however did not observe any indications of concern associated with these cracks. A qualified person should prep, prime, paint as desired.

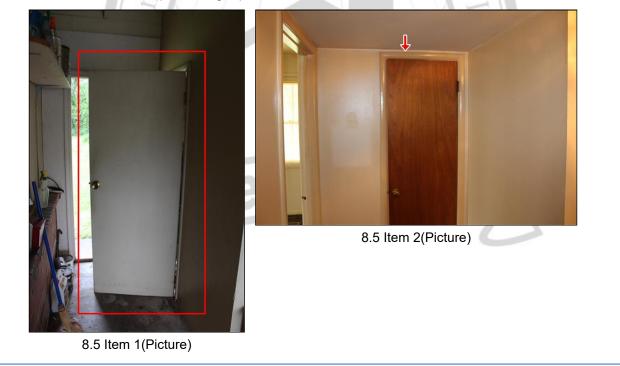
- 8.5 (1) Condition(s) observed with Doors:
  - The door jamb is loose at the garage closet which will need to be secured.

**Recommendation:** A qualified contractor should inspect further and make corrections to item(s) as well as any other related condition discovered while performing repairs.

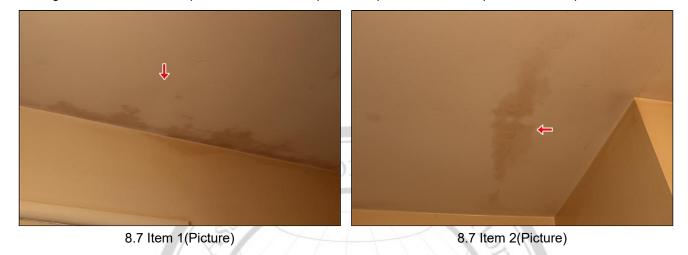
• Observed apparent surface fungal growth in the bathroom(s) on ceiling surfaces. This condition appears as result of no ventilation fan inside the bathroom which should be installed. Isolated areas of apparent fungal growth less than 100 sq. ft. can be cleaned up with soap and water, then painted to encapsulate.

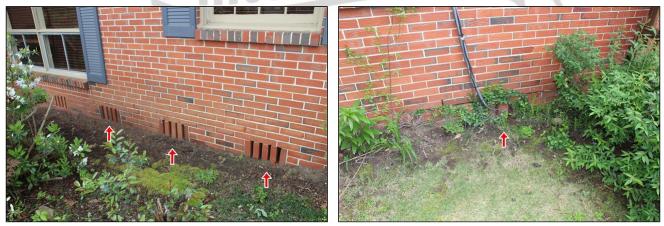
9.2 Item 1(Picture)

9.2 (1) Condition(s) observed with Ventilation of Attic & Foundation Areas:

**Recommendation:** A qualified contractor should inspect further and make corrections to item(s) as well as any other related condition discovered while performing repairs.

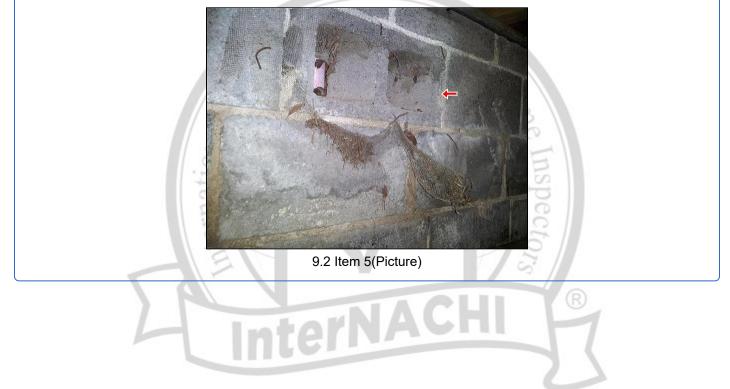
9.2 Item 4(Picture)

- $\textbf{9.2 (2)} \quad \text{Condition(s) observed with Ventilation of Attic \& Foundation Areas:}$ 
  - Observed missing or damaged screening at the soffit vents in attic.
  - Observed missing or damaged screening at the crawl space vents which will need correction.

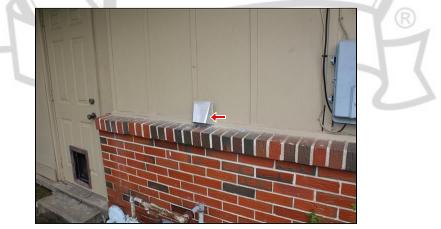
9.3 Item 2(Picture)

- 9.3 (2) Condition(s) observed with Venting Systems:
  - The damper for the dryer exhaust is stuck open which will need to be adjusted/cleaned so it can close when not in use.

**Recommendation:** A qualified contractor should inspect further and make corrections to item(s) as well as any other related condition discovered while performing repairs.

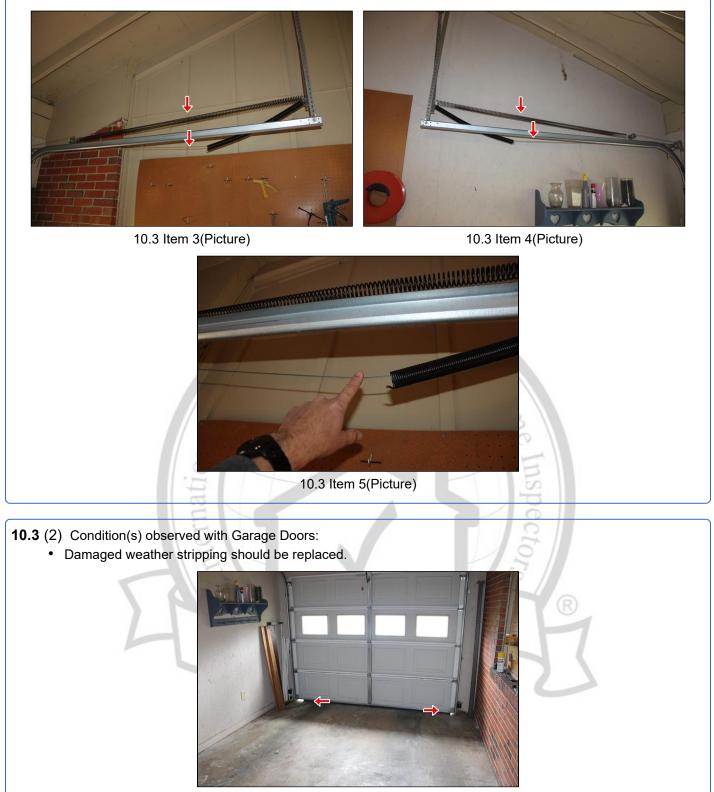
10.3 Item 6(Picture)

- The inspector observed replaced springs at the garage door, however the safety cable was not installed in the new springs which will need correction for safety.
- The garage door is damaged at top of the door and will need additional support bracing to prevent further deterioration of the damaged area.

**Recommendation:** A qualified contractor should inspect further and make corrections to item(s) as well as any other related condition discovered while performing repairs.
