Inspection Report

Red Mountain Inspections LLC

INSPECTED PROPERTY ADDRESS: 1473 Sunnyside Drive Birmingham AL 35216

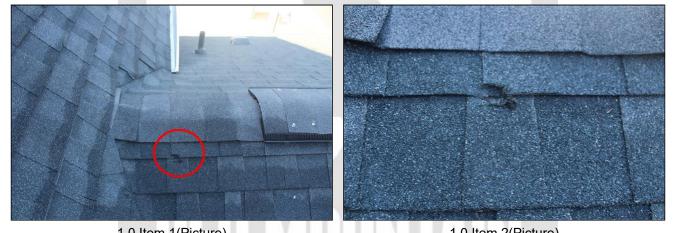
1.0 Item 1(Picture)

1.0 Condition(s) observed with Roof Covering(s):

Minor mechanical damage observed at one roof shingle on the rear ridge.

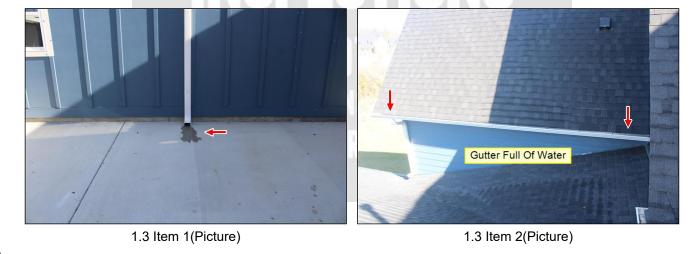
1.3 Condition(s) observed with the Roof Drainage Systems:

The gutters are holding water in areas which will need correction.

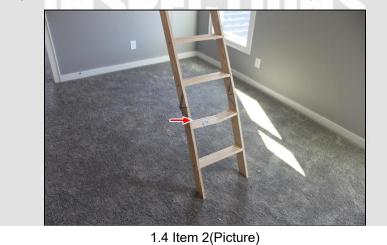
1.4 (2) Broken stair at the pull down stairs for attic access will need to be replaced.

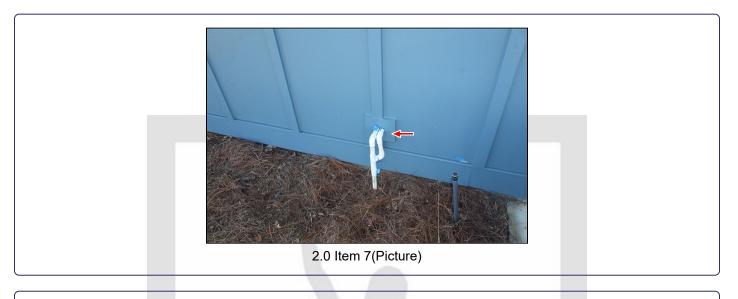
2.0 Condition(s) observed with the Siding, Flashing & Trim:

Where a pipe/wire penetrates an exterior wall, a waterproof seal shall be made on the exterior of the wall by a waterproof sealant applied at the joint between the wall and the pipe/wire or flashing of an approved elastomeric material.

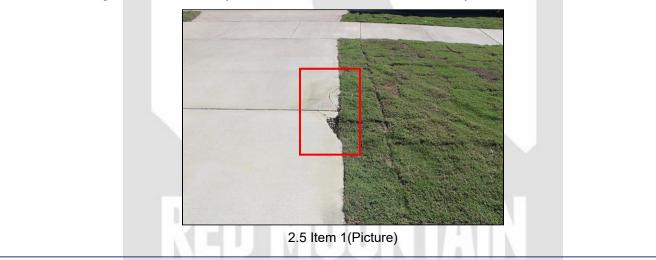
2.5 Condition(s) observed at Vegetation, Grading, Drainage, Driveways, Patio Floor, Walkways & Retaining Walls:

Observed a damaged / broken driveway slab at the front left side of the driveway.

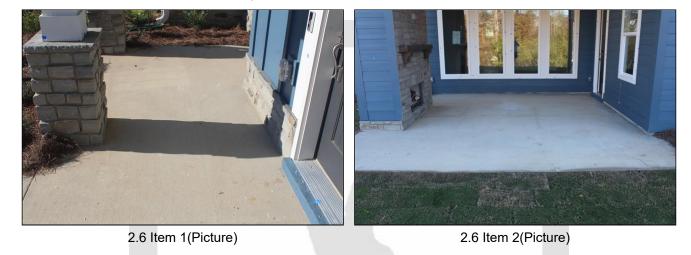
2.6 Conditions observed at the Exterior:

Observed minor cracking in the porch and patio slab at the exterior, however we did not observe any concerns associated with these cracks at time of inspection.

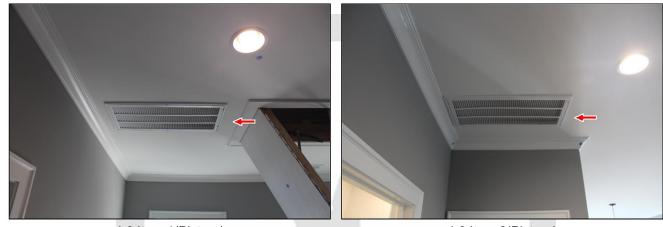
4.6 Item 1(Picture)

4.6 Condition(s) observed with filter location:

The filters are located in the ceiling upstairs for upstairs unit and in the common hallway ceiling and rear foyer ceiling for the main level.

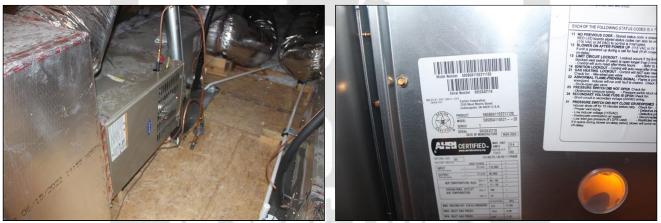
4.7 Item 3(Picture)

4.7 Condition(s) observed with the Cooling & Air Handler Equipment:

A **0** degree delta on the cooling system downstairs indicates that the unit is **not** cooling properly and a licensed HVAC Technician should inspect further and correct as needed.

This HVAC system did produce heat and operated properly in heat mode, however when functionally testing AC mode, the compressor outside does not cycle on. Power was observed at the compressor unit outside and at the air handler inside the attic. Further evaluation is needed to determine the cause.

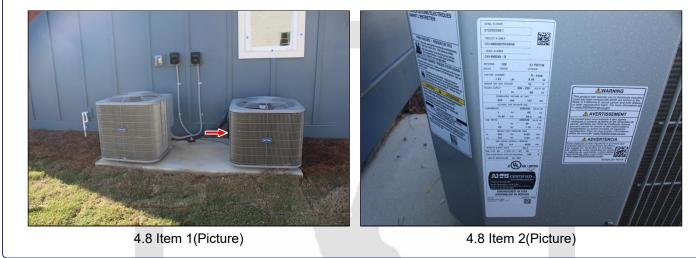
4.8 Condition(s) observed with the Cooling & Air Handler Equipment:

A 17 degree delta on the cooling system indicates the unit is cooling properly and the range in temperature drop is normal.

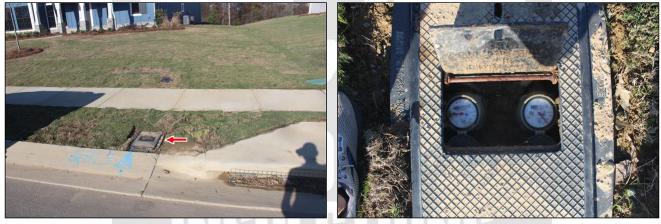
5.0 Item 1(Picture)

5.0 Condition(s) observed with Main Water Shut-Off Device:

The main shut off is located outside in the ground at the water meter. Also there is a main shut off in the garage where the main water line enters the home.

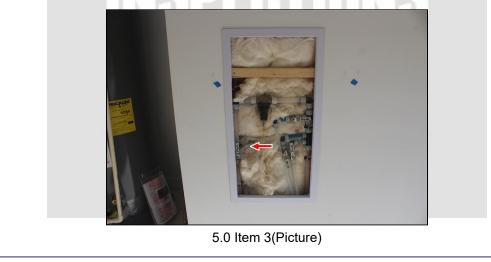
5.2 (2) The inspector observed low flow hot water supply at the primary bath tub. The photos first depict cold water running, then hot water running at a reduced flow rate.

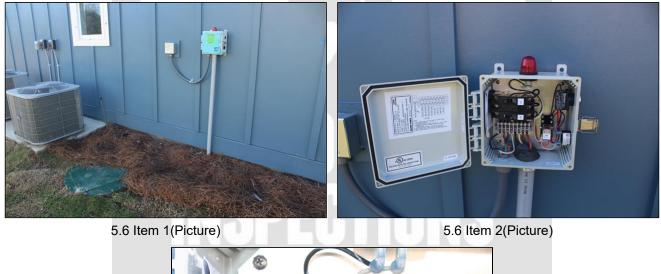
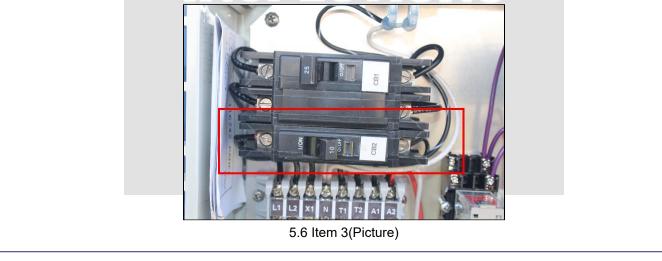
5.6 Condition(s) observed with the sump:

The inspector observed one of the breakers to be off at time of inspection at the septic pump / grinder alarm system outside indicating a potential defect which should be evaluated further and corrections performed if needed.

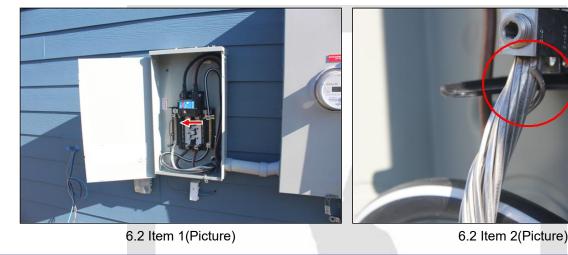
6.2 Condition(s) observed with Branch Circuit Conductors & Overcurrent Protection Devices:

Connections and terminations of conductors shall not be loose.

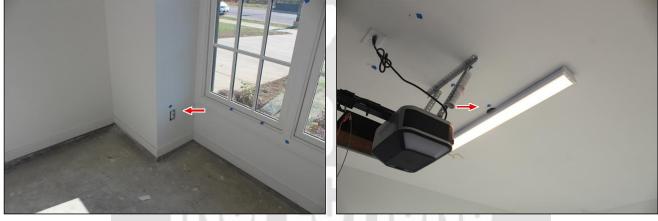
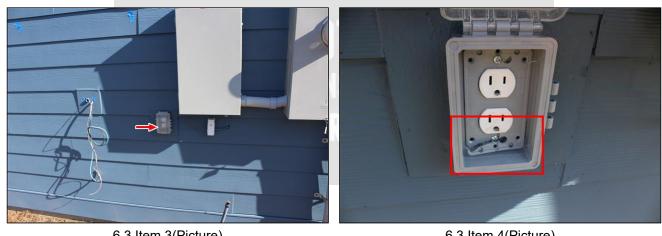
6.3 Item 1(Picture)

6.3 (1) Condition(s) observed with Switches, Receptacles, Light Fixtures & Visible Wiring:

Damaged or missing outlet / junction covers will need to be replaced.

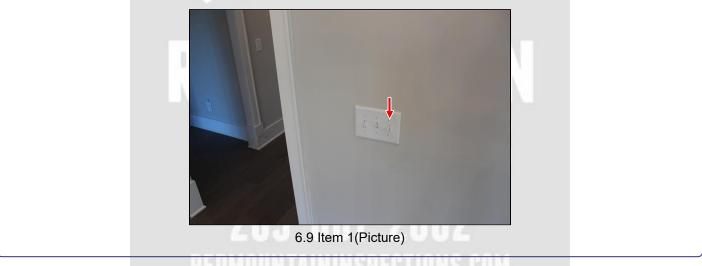
6.9 Condition(s) observed with Switches, Receptacles, Light Fixtures & Visible Wiring such as:

Noted at least one snap switch at the interior which did not appear to control any outlet. This is common in homes that have been renovated over time. We did not observe any indications of concern associated at time of inspection. This info provided for your reference.

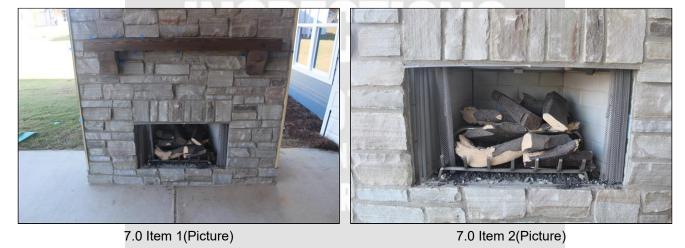
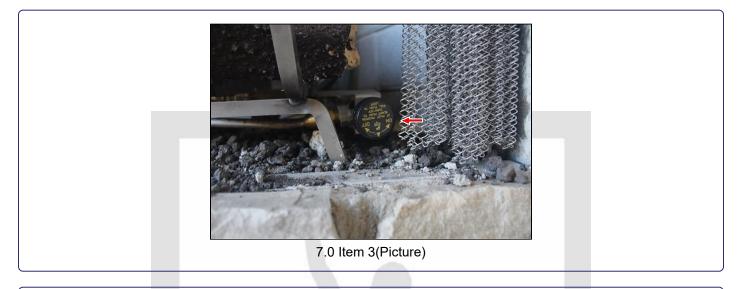
7.0 Condition(s) observed with Gas / LP Firelogs and Fireplaces:

The gas logs were not properly configured upon arrival which causes excess Carbon Monoxide to be produced when operating. These logs will need to be properly configured as per the manufactures installation instructions. The ignitor at the gas log set was non-functional at time of inspection. I was unable to functionally test the outdoor firelogs as result of the defects observed.

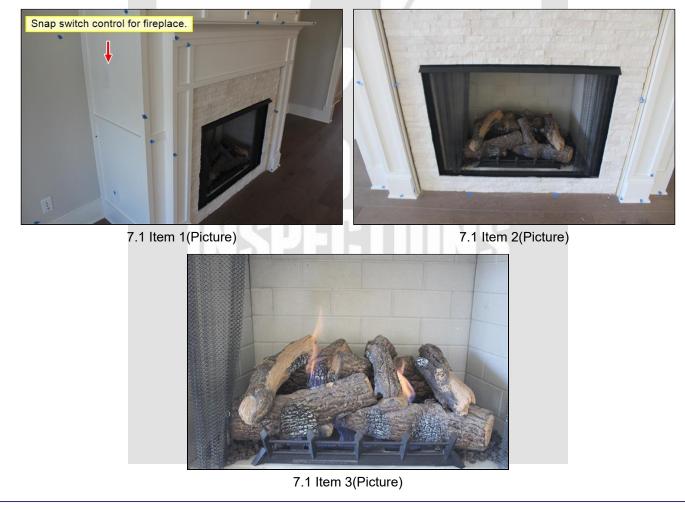
7.1 Condition(s) observed with Gas / LP Firelogs and Fireplaces:

The switch on the wall will fire the logs once the pilot has been lit.

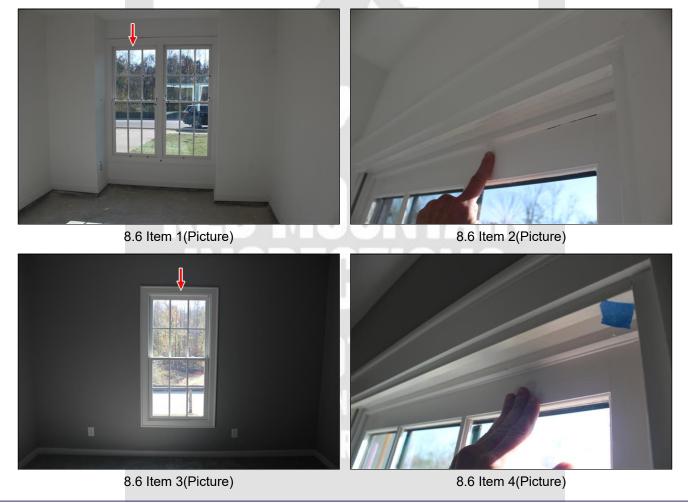
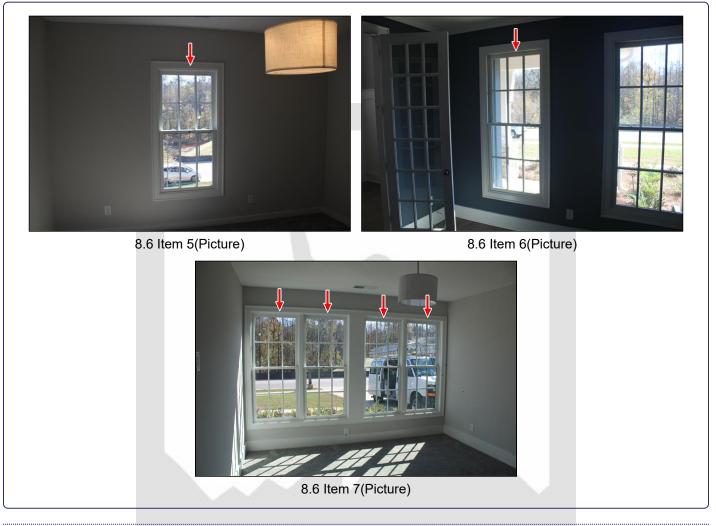
8.6 Condition(s) observed with Windows:

One or more windows are stuck or painted shut in the home. You should maintain at least one operable window in each sleeping room of the home as your secondary fire escape.

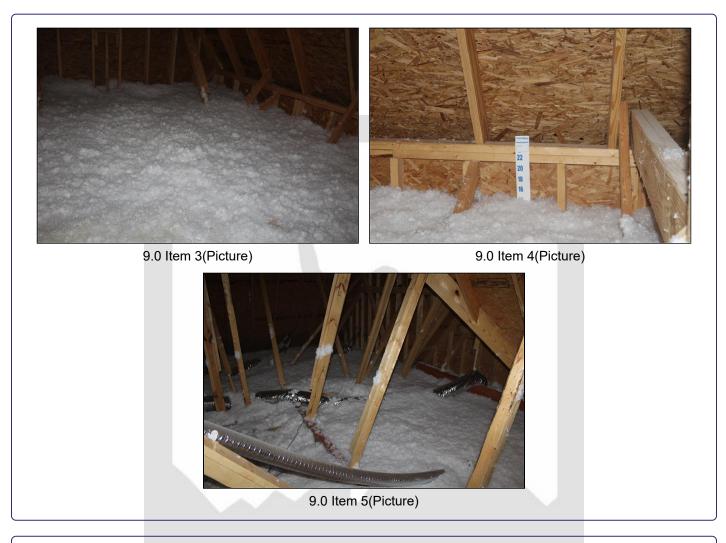
9.0 Item 2(Picture)

Observed loose screening at the soffit vents for the attic which should be corrected to prevent pest entry into the attic space.

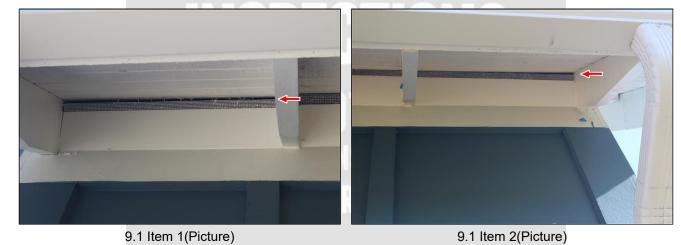
9.1 Condition(s) observed with Ventilation of Attic & Foundation Areas:

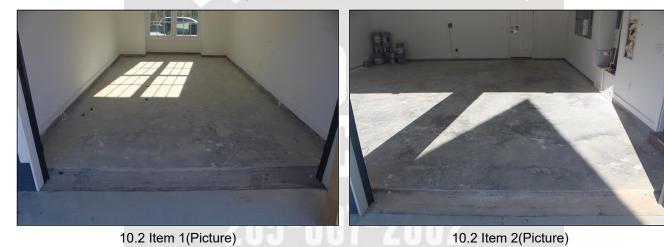
10.2 Observed cracking in the slab flooring at the garage, however we did not observe any structural concerns associated with these cracks at time of inspection.
