Inspection Report

Red Mountain Inspections LLC

2013 Red Mountain Road

Trussville AL 35173

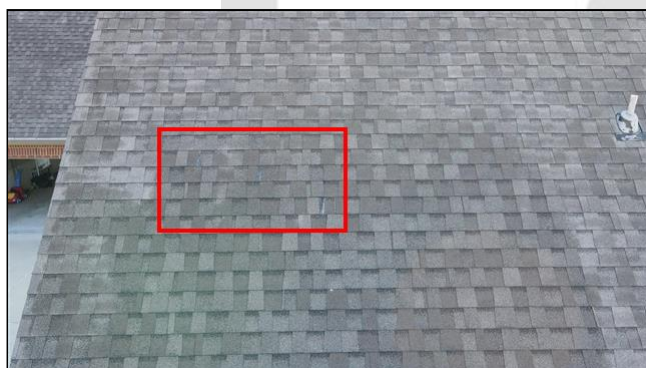
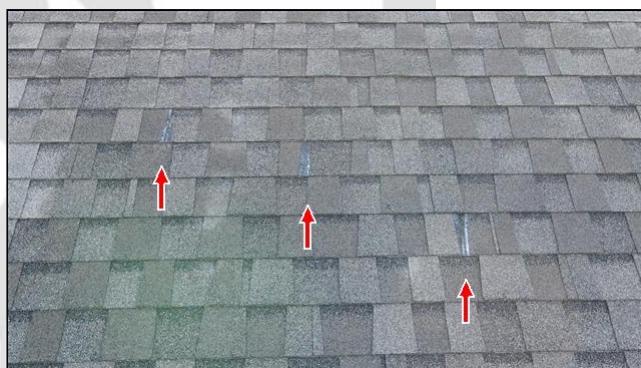
1.0 Item 1(Picture)

1.0 Condition(s) observed with Roof Covering(s):

The inspector observed several damaged shingles at the right slope of the home that appears as result of manufacturer defect. This condition should be evaluated further and corrections performed as needed.

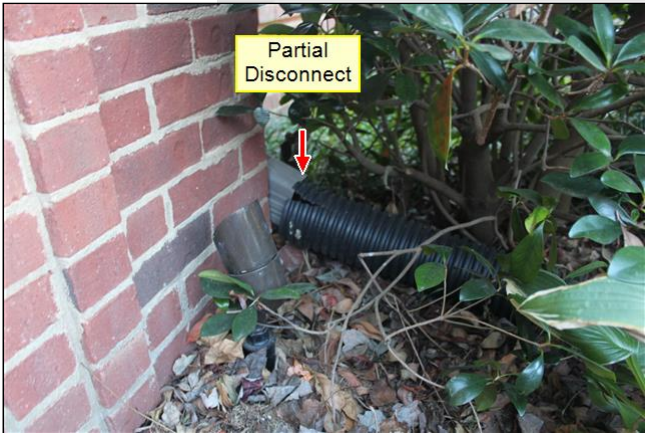
1.3 Item 1(Picture)

1.3 Condition(s) observed with the Roof Drainage Systems:

Downspout extenders should be installed as to discharge water away from the foundation.

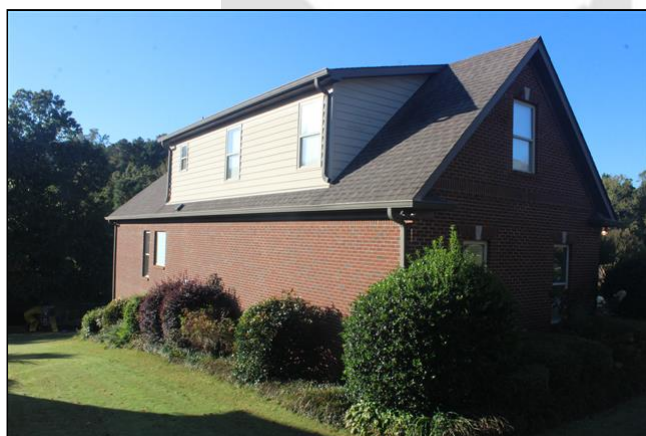
2.0 Item 1(Picture)

2.0 Condition(s) observed with the Siding, Flashing & Trim:

Where a pipe/wire penetrates an exterior wall, a waterproof seal shall be made on the exterior of the wall by a waterproof sealant applied at the joint between the wall and the pipe/wire or flashing of an approved elastomeric material.

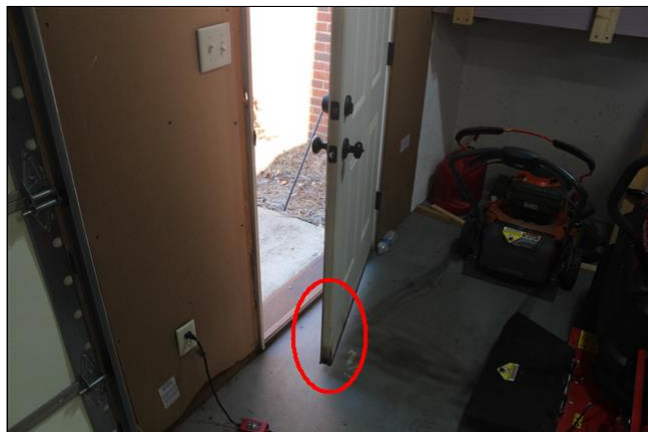
2.2 Item 1(Picture)

2.2 Condition(s) observed with Doors (Exterior):

General maintenance of door paint and caulk is needed at exterior side of door(s). Minor deterioration observed at the garage egress door to the driveway.

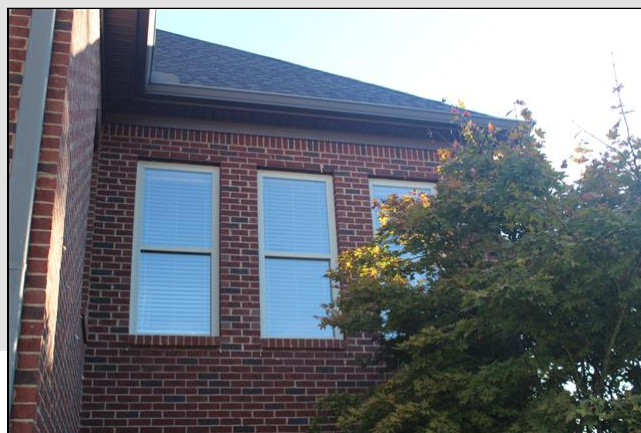
2.3 Item 1(Picture)

2.3 Condition(s) observed with Windows (Exterior):

General maintenance of window caulking is needed at the exterior side of window(s) where caulking has begun to fail.

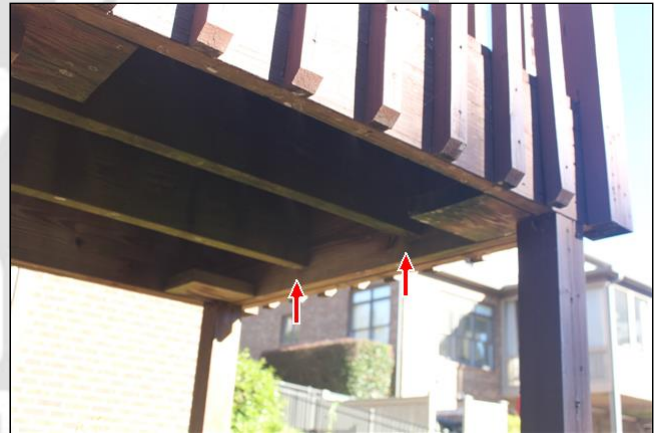
2.4 Item 1(Picture)

2.4 Condition(s) observed with Decks, Balconies, Stoops, Steps, Porches, Patio/Cover & Applicable Railings:

- Deck ledgers shall not support concentrated loads from beams or girders.
- Missing joist hangers will need to be installed where joists end into rim joist.
- The maximum span of 6.0' for cut stringers has been exceeded. Inspector recommends installing a rigid beam at mid span to add support to the structure.
- Damaged stringer should be repaired or replaced.
- Loose stair treads will need to be secured, nails which have backed out should be set.
- Deteriorated or damaged stair treads will need to be replaced.

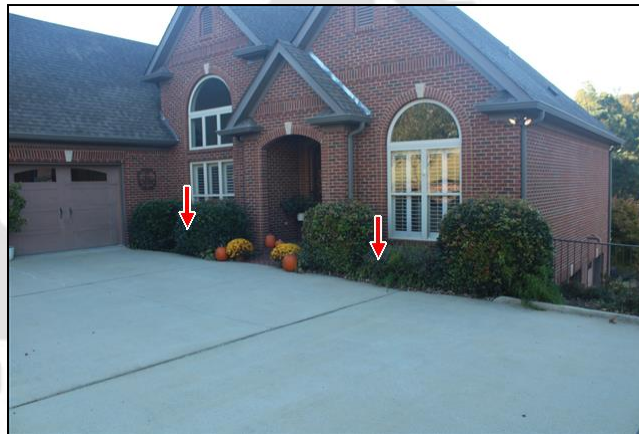
2.5 Item 1(Picture)

2.5 Condition(s) observed at Vegetation, Grading, Drainage, Driveways, Patio Floor, Walkways & Retaining Walls:

There is pitting against the home at the front. This area does not appear to drain water away from home and needs landscaping and drainage corrected.

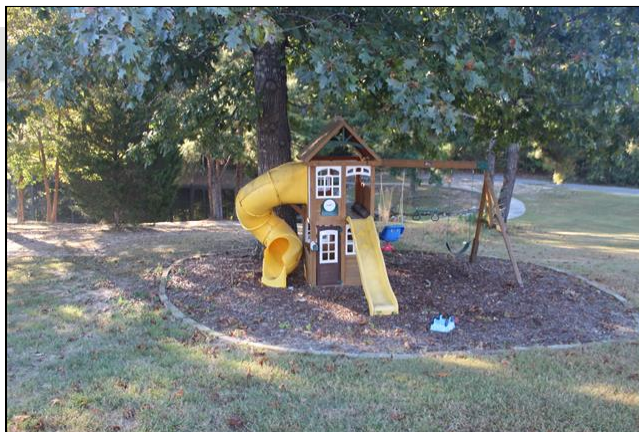
2.6 Item 1(Picture)

2.6 Condition(s) observed at Additional Buildings on the Property:

I did not inspect any additional structures; I only inspected the main structure. Deficiencies may exist with these structures or buildings. Our company makes no representation to the condition of these structures or buildings.

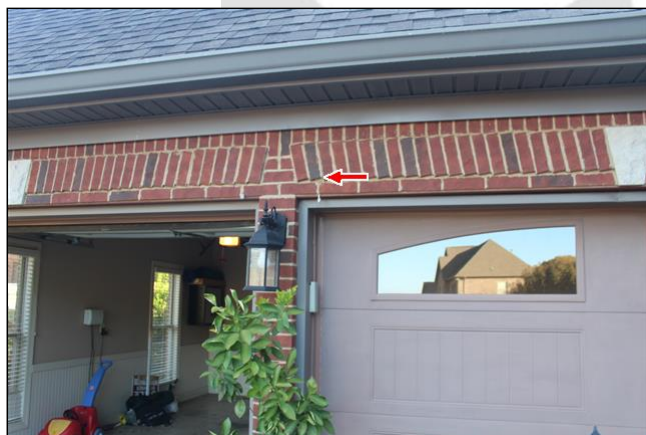
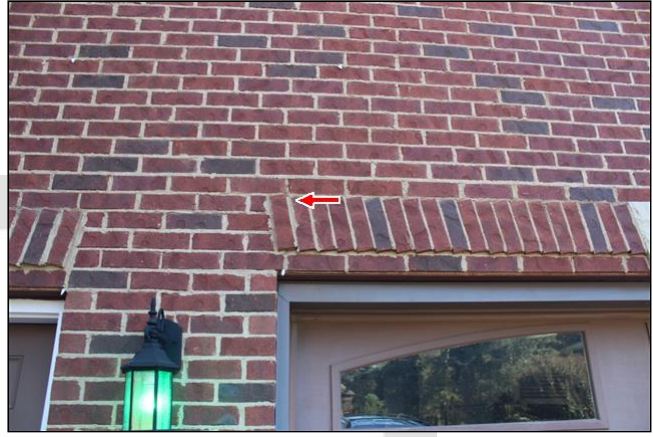
2.7 Item 1(Picture)

2.7 (1) Observed minor cracking in the driveway slabs at the exterior, however we did not observe any concerns associated with these cracks at time of inspection.

2.7 (2) Observed a few areas of cracking in the mortar at the brick veneer, however we did not observe any structural concerns associated with these cracks at time of inspection.

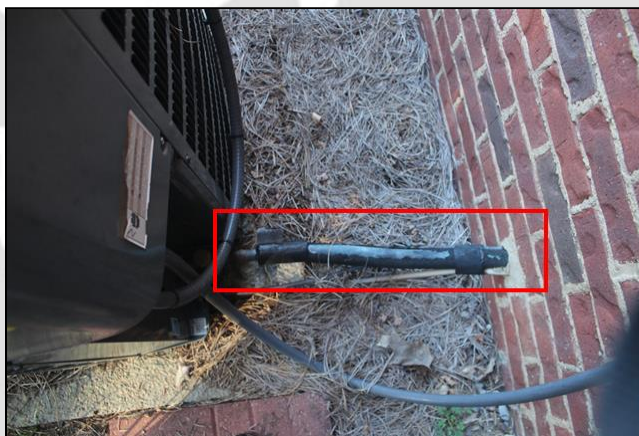
4.3 Item 1(Picture)

4.3 Condition(s) observed with the Distribution Systems:

Refrigerant Line Insulation was observed to be missing / damaged which should be replaced as to prevent condensation and improve energy efficiency.

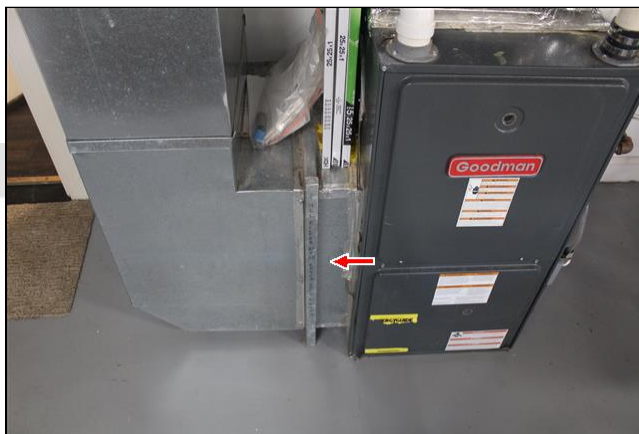
4.6 Item 1(Picture)

4.6 The filter is located at the unit in the garage.

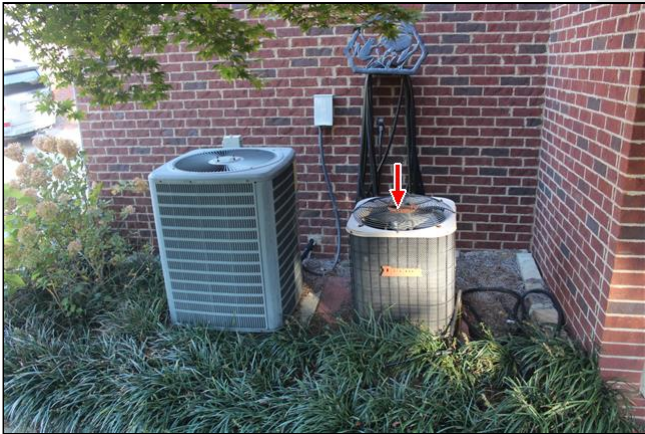
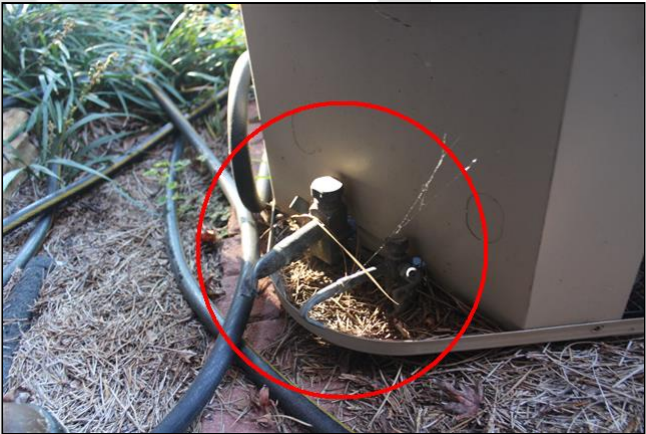
4.8 Item 1(Picture)

4.8 Condition(s) observed with the HVAC Systems:

The inspector observed a secondary / non-operational Ducane AC unit sitting beside the primary AC unit outside. This system is old and has not been connected to the home; this info provided for your reference.

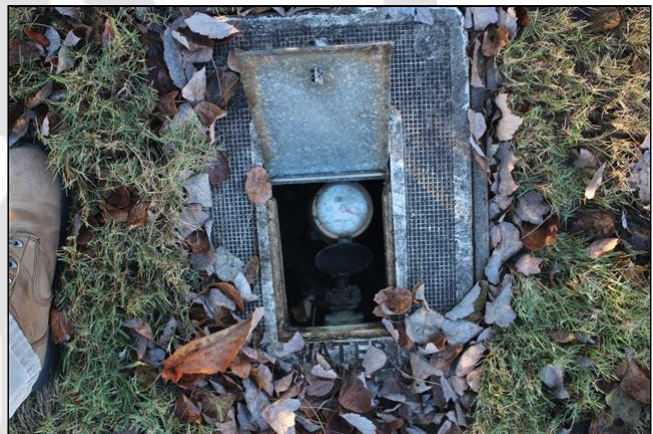
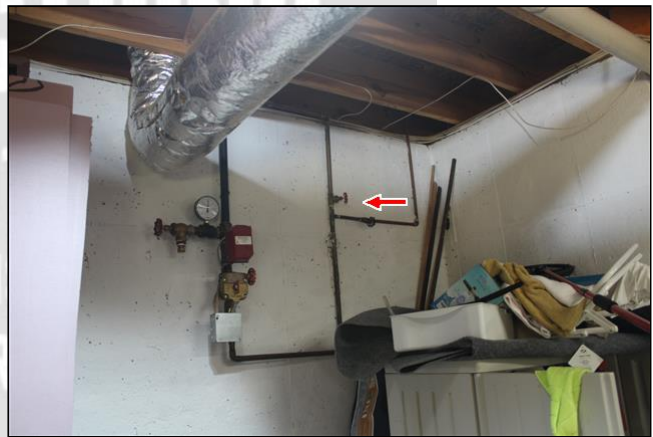
5.0 Item 1(Picture)

5.0 Condition(s) observed with Main Water Shut-Off Device:

The main shut off is located outside in the ground at the water meter. Also there is a main shut off in the garage where the main water line enters the home.

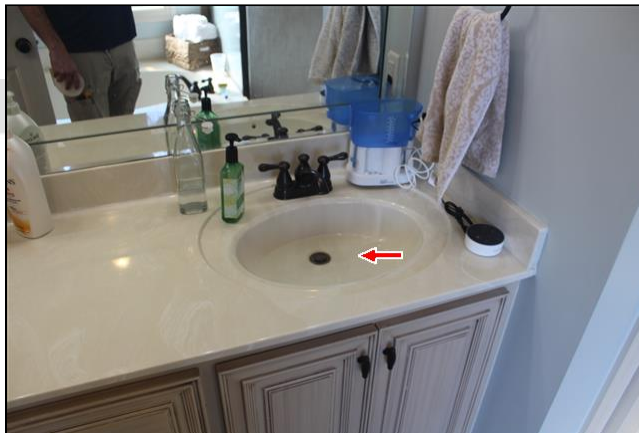
5.1 Item 1(Picture)

5.1 (1) Condition(s) observed with Plumbing Drain, Waste & Vent Systems:

The right side Primary Bath sink was partially clogged which will need to be cleared as to drain properly.

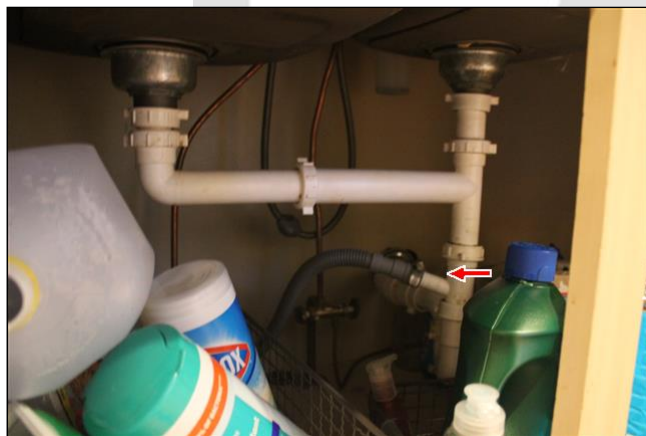
5.1 Item 2(Picture)

**5.1 (2)** In the diagram pictured, you'll notice that the dishwasher drain makes a high loop underneath the kitchen sink. This is the minimum requirement for every dishwasher drain installation; it's required by every dishwasher manufacturer. A high loop should be created on this drain line for proper installation and operation of the dishwasher.

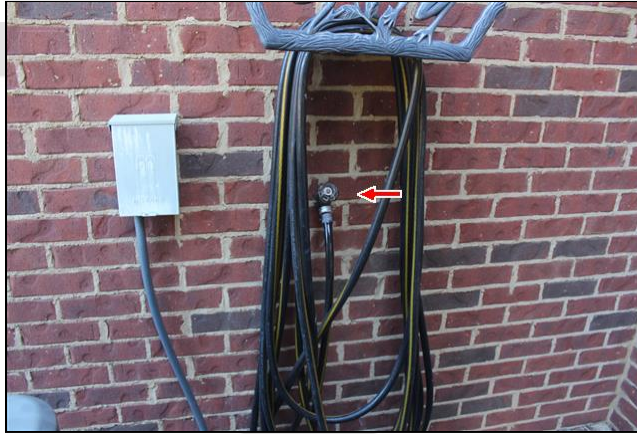
5.2 Item 1(Picture)

5.2 (1) Condition(s) observed with Plumbing Water Supply & Distribution Systems & Fixtures:

The hose bibb at the exterior was observed to have a bad seal at time of inspection. A new seal will likely correct this issue.

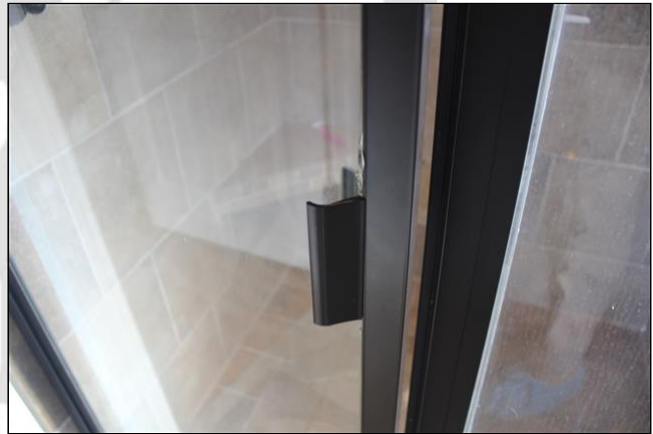
5.2 Item 2(Picture)

5.2 (2) The primary bath shower door needs strike/latch/hinge adjustments as to shut/latch properly. The door handle is loose which should be secured when performing repairs.

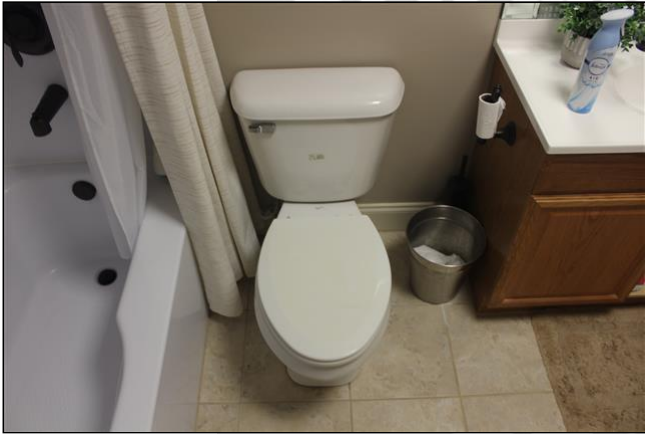
5.2 Item 8(Picture)

**5.2 (4)** The toilet runs continuously at the Basement Bath which will need correction.

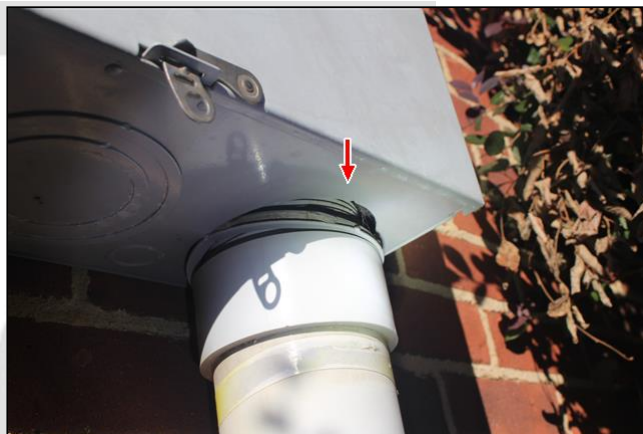
6.0 Item 1(Picture)

6.0 Condition(s) observed with Service Entrance Lines:

The service entry conduit entering the meter can has settled and the conduit has begun detaching from the box.

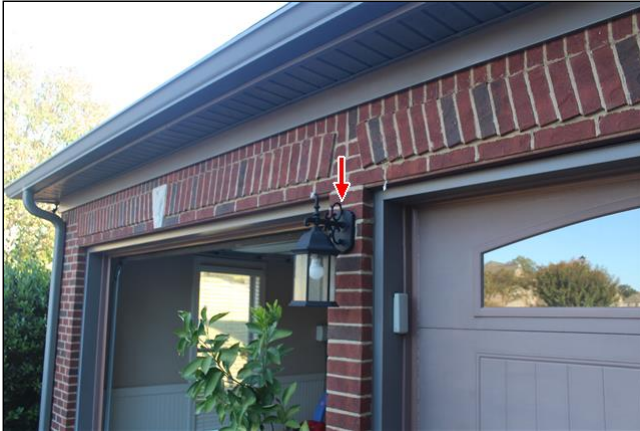
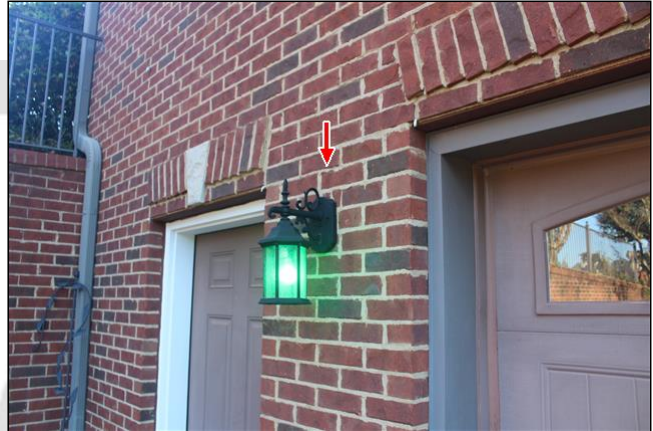
6.3 Item 1(Picture)

6.3 (1) Condition(s) observed with Switches, Receptacles, Light Fixtures & Visible Wiring:

Exterior outlets should be sealed to wall with a clear sealant at the top and sides to prevent water entry.

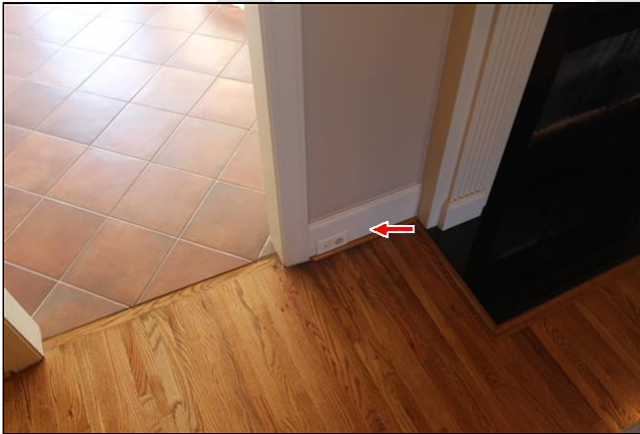
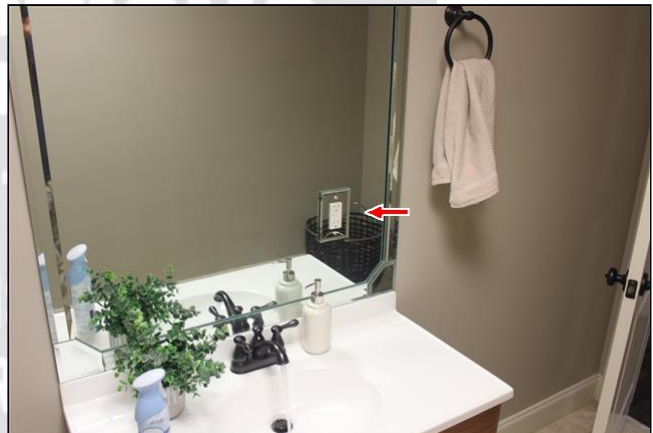
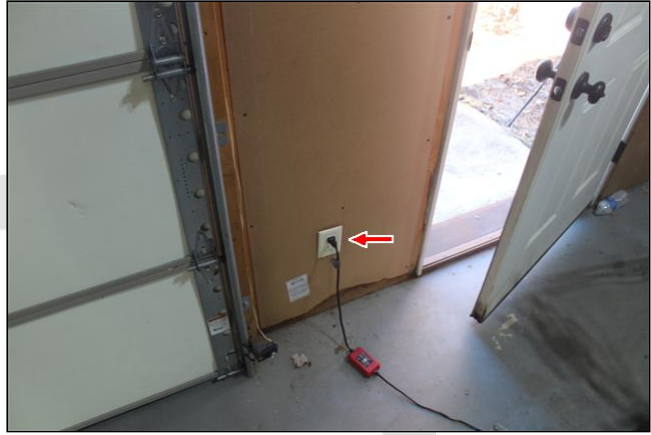
6.3 Item 3(Picture)

6.3 (2) Loose receptacle(s) will need to be secured.

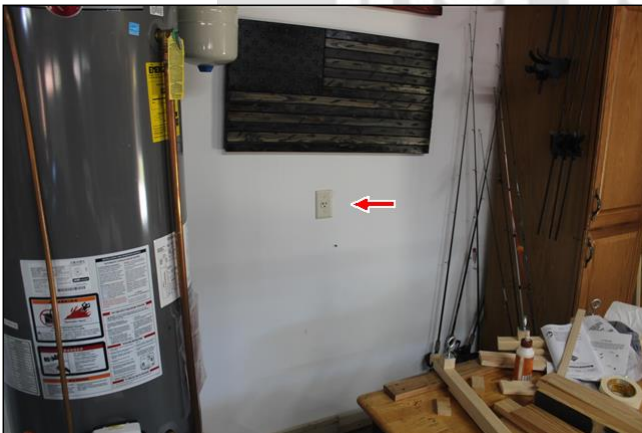
6.4 Item 1(Picture)

**6.4** Condition(s) observed with GFCI / AFCI Protection, Polarity & Grounding of Receptacles:

One or more GFCI (Ground Fault Circuit Interrupter) receptacles did not trip/reset when tested (defective/missing).

- Garage

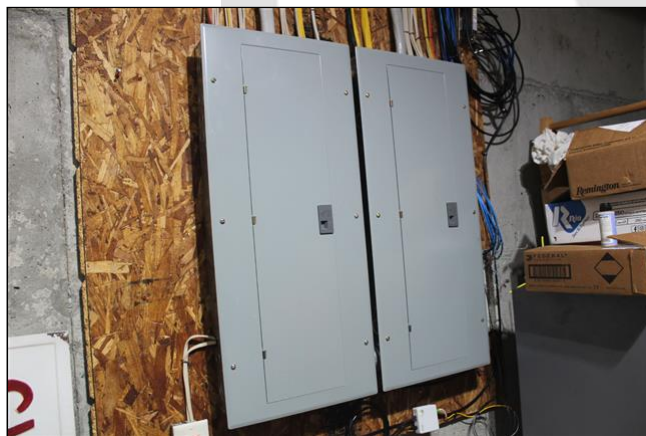
6.6 Item 1(Picture)

6.6 The main and sub panel boxes are located at the basement.

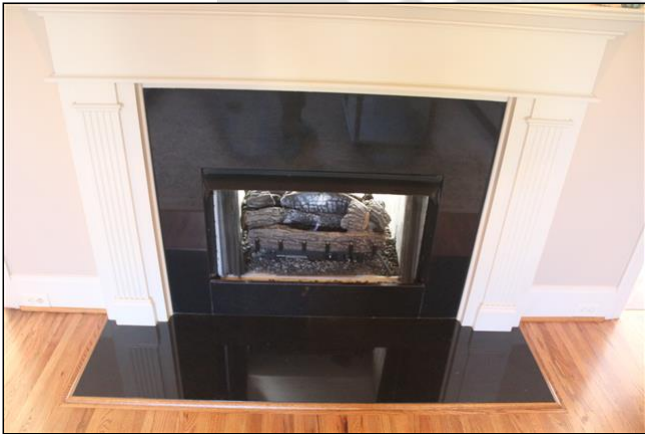
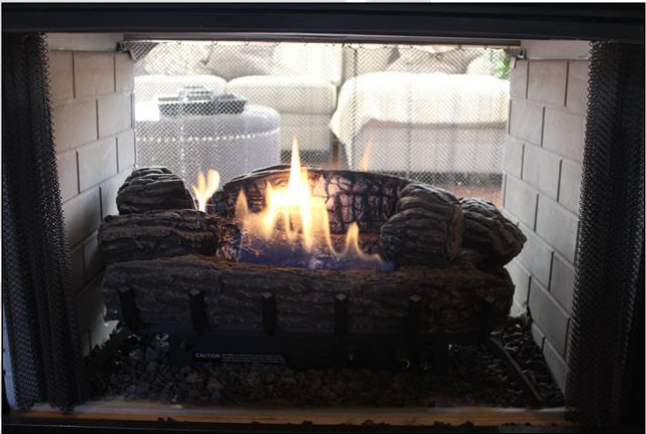
7.0 Item 1(Picture)

7.0 Condition(s) observed with Gas / LP Firelogs and Fireplaces:

Non vented gas logs sets are extremely safe when properly operated. You should familiarize yourself with the proper operation of the log set installed by reviewing the manufacturers operators manual.

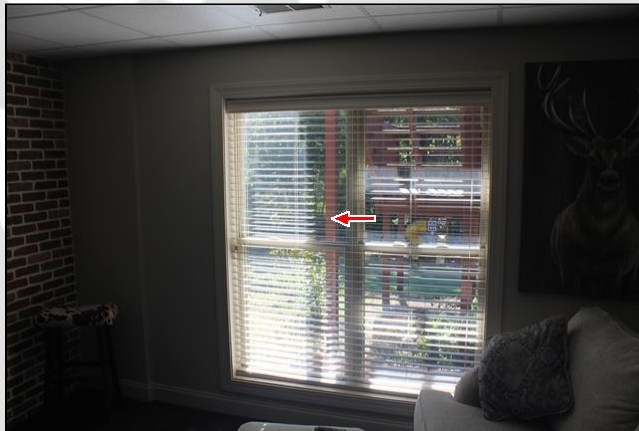
8.6 Item 1(Picture)

8.6 Condition(s) observed with Windows:

Condensation visible between the glass at a double-pane windows indicates that the desiccant strip designed to absorb moisture from the space between the panes has become saturated and will no longer prevent condensation from forming. In some situations repair is possible, but if irreparable damage has occurred, the window will need to be replaced to correct.

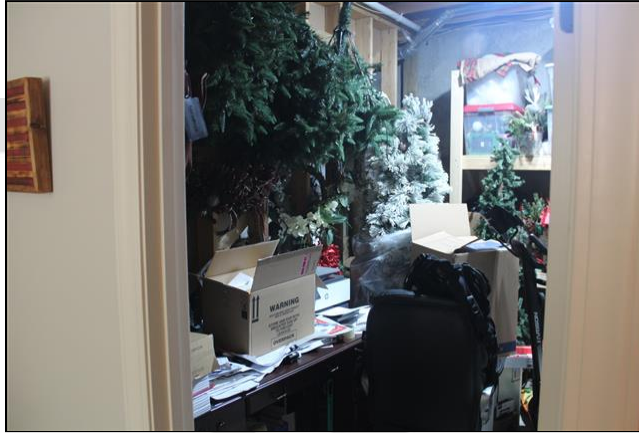
8.8 Item 1(Picture)

8.8 Condition(s) observed at the Interior:

Personal storage items stored inside the home restricted access in areas, however no indications of concern were observed at time of inspection.

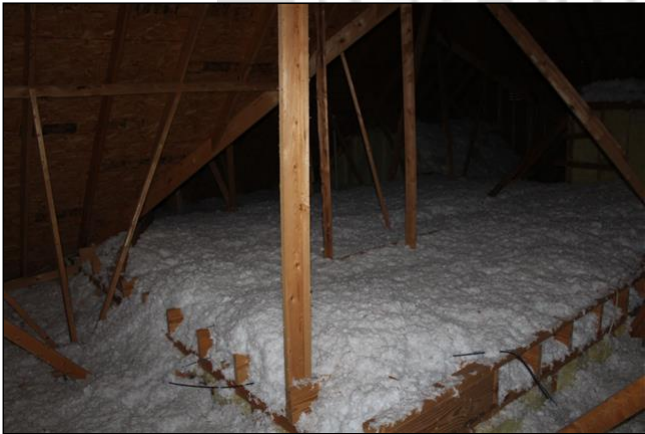
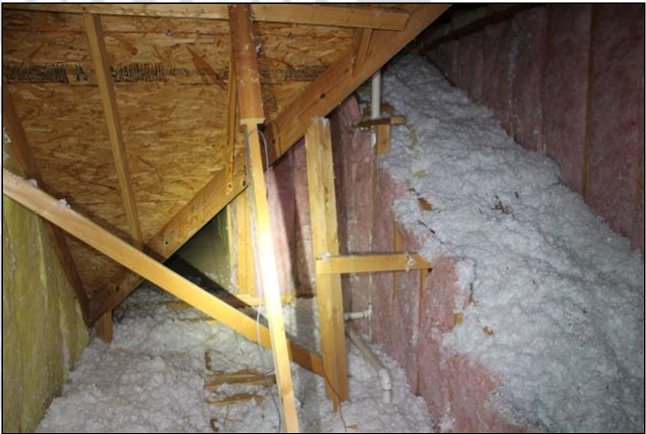
9.0 Item 1(Picture)

9.0 Condition(s) observed with Insulation in Attic:

Attic insulation is about 12 inches thick or 30 R Value.

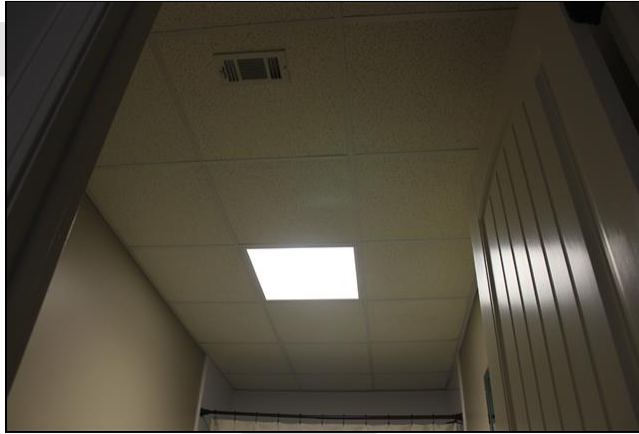
9.2 Item 1(Picture)

9.2 Condition(s) observed with Venting Systems:

Bathrooms, water closet compartments and other similar rooms shall be provided with an operable window or mechanical ventilation which was not present in the basement bathroom at time of inspection.

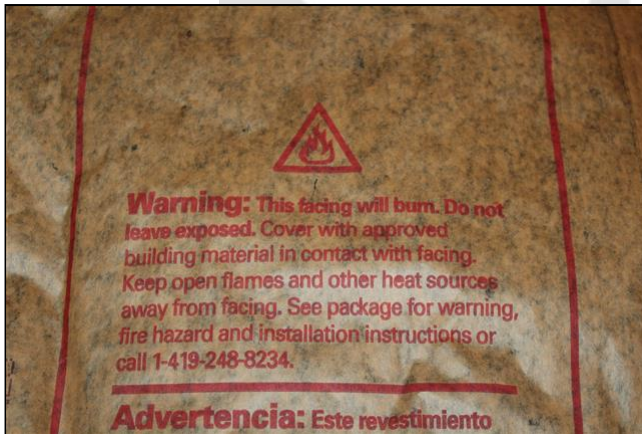
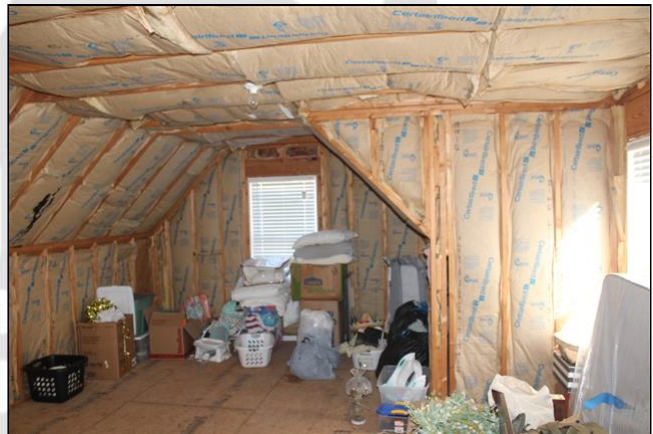
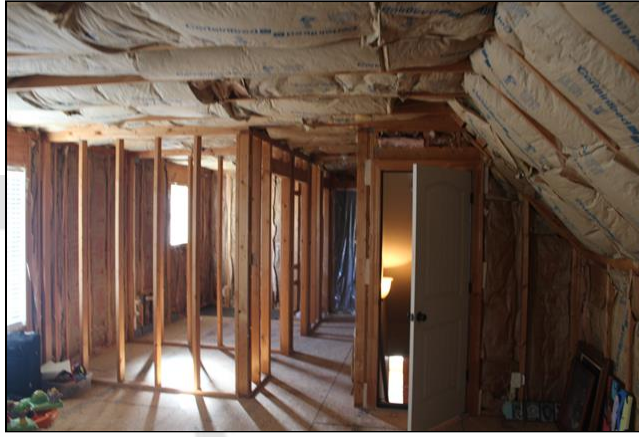
9.3 Item 1(Picture)

9.3 Condition(s) observed with Insulation:

Fiberglass insulation is non-combustible. Kraft and standard foil facings are combustible and should not be left exposed. The warning printed on insulation states that the facing will burn, do not leave exposed and to cover with an approved building material. Corrections should be performed for fire safety.

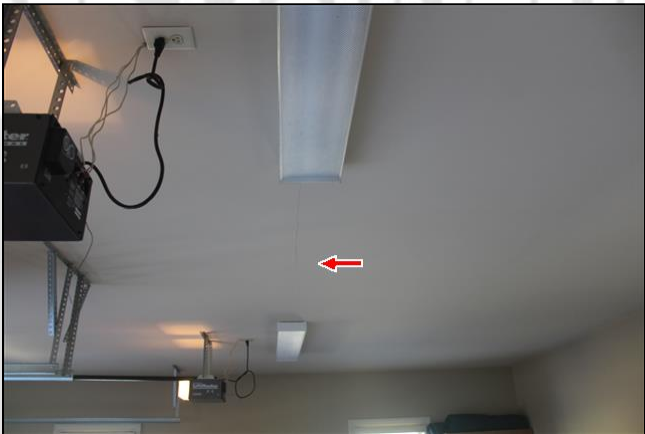
10.0 Item 1(Picture)

Observed hairline cracks at the interior sheetrock ceiling, however did not observe any indications of concern associated with these cracks. A qualified person should prep, prime, paint as desired.

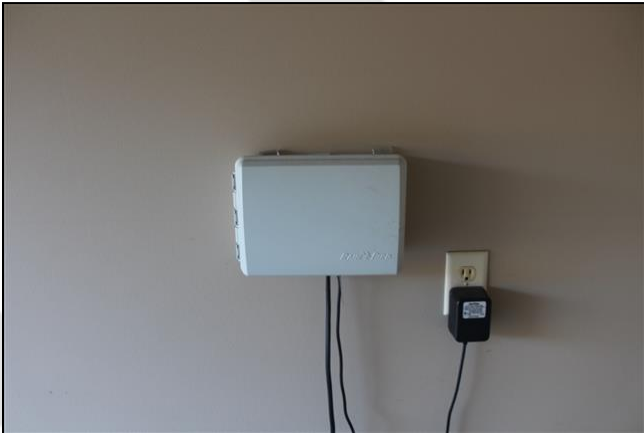
12.0 Item 1(Picture)

12.0 We did not test the sprinkler system since this is outside the scope of our standard home inspection. Further evaluation of the sprinkler system should be performed as desired.
