Inspection Report

Red Mountain Inspections LLC Chad M. Allen - AL HI-4007 504 Cattail Circle Gardendale, AL 35071 205-607-2082

315 Cahaba Lilies Lane Pelham AL 35124

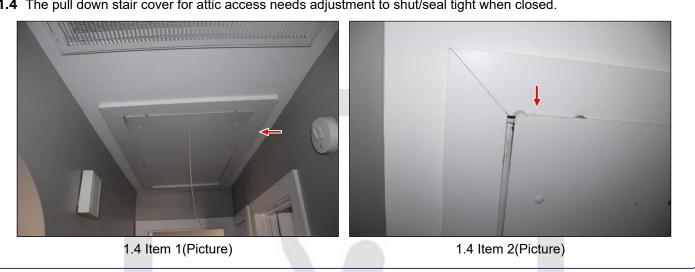
1.4 The pull down stair cover for attic access needs adjustment to shut/seal tight when closed.

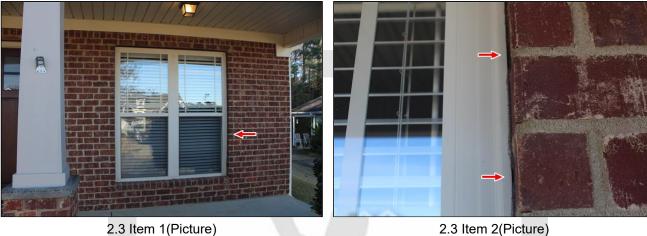
2.3 Item 1(Picture)

2.3 General maintenance of window caulking is needed at the exterior side of window(s) where caulking has begun to fail.

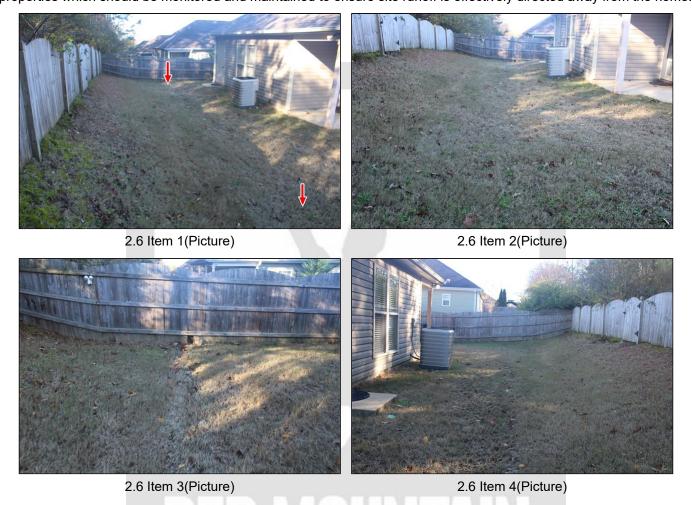
2.6 (1) Observed a swell located at the rear of the home intended to divert site drainage for the surrounding properties which should be monitored and maintained to ensure site runoff is effectively directed away from the home.

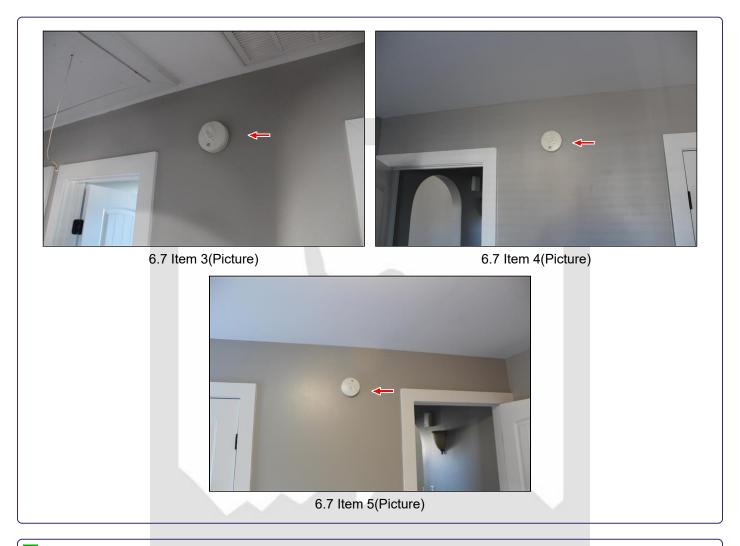
6.7 Item 2(Picture)

6.7 Smoke alarms have a limited life expectancy. The National Fire Protection Association (NFPA) recommends every alarm be replaced after 10 years and that batteries be replaced every six months (when applicable). Due to the age of the installed Smoke/Heat Alarms, the alarms should be replaced for increased fire safety.

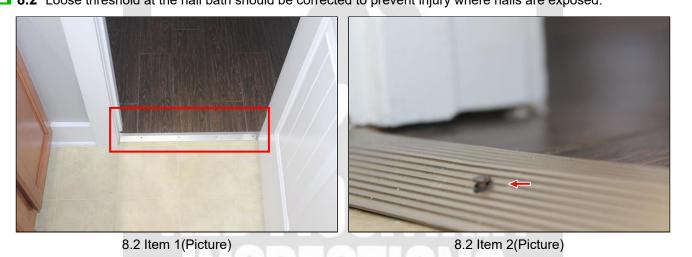
8.2 Loose threshold at the hall bath should be corrected to prevent injury where nails are exposed.
